Sailors and Marines reducing mishaps **BRAVGO** *Zulu*

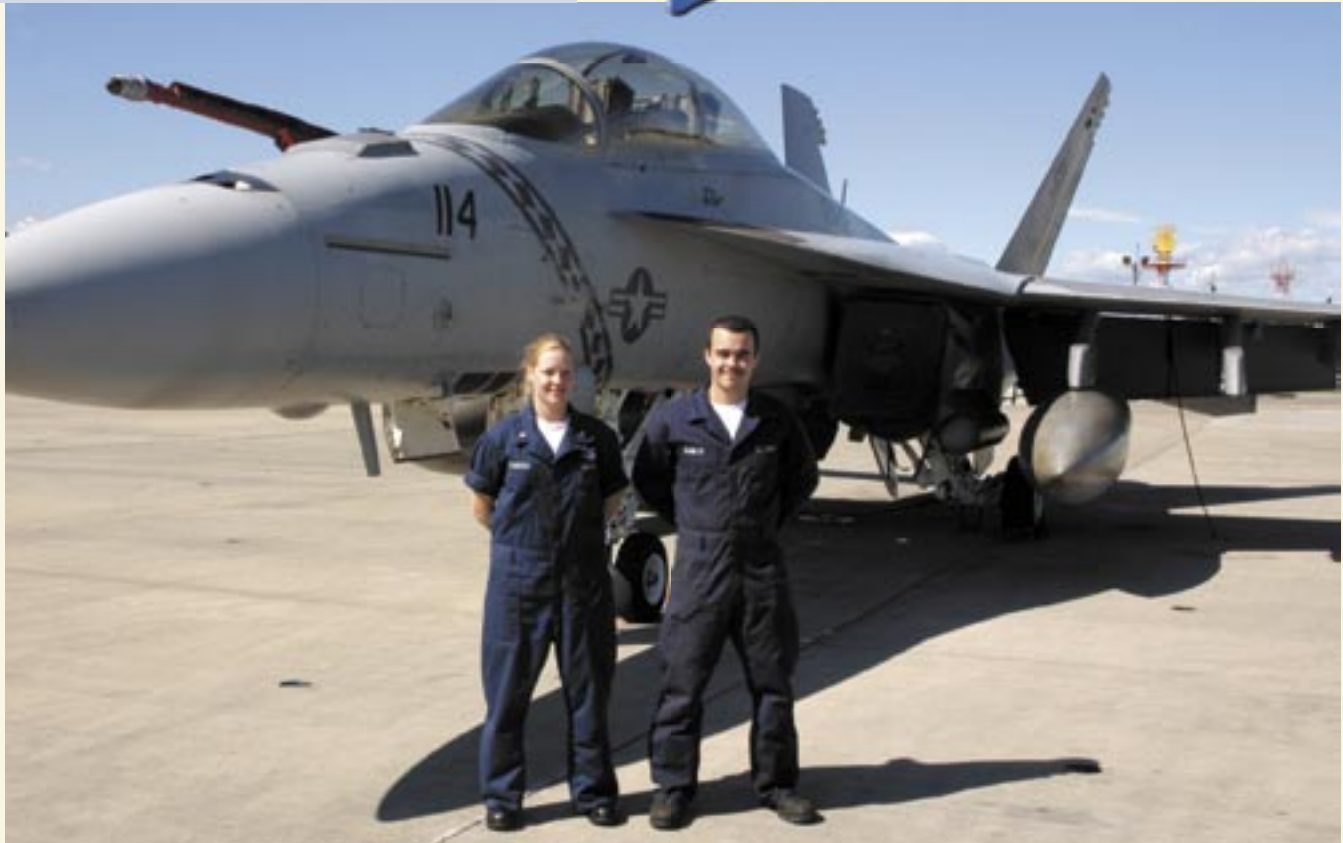
**AN David Bowles and AE3(AW) Heather Evanger
VFA-102**

As the jet started moving aft, the plane captain (AN Bowles) was watching and waiting to prep the jet for launch. He was surprised to see the towbar's attaching points break away from the nosewheel axle, causing the towbar to drop down into the rims of the

nosewheel. The tractor lost positive control of 114.

A yellowshirt was looking at the jet's port main-mount, ensuring safe separation from the scupper, and didn't realize the towbar had disengaged from the tow points on the nosewheel axle. The wing-walkers were looking at the director, unaware that 114 no longer was attached to the tractor. Seeing the aircraft rolling aft toward the rounddown, AN Bowles decided the tractor would be unable to stop the jet's movement. He promptly signaled for AE3 Evanger to apply the brakes. AE3 Evanger immediately applied the aircraft's emergency braking system, stopping the jet two feet from the rounddown. The jet was then chocked, chained, and inspected. AN Bowles discovered both nosewheel rims were bent, downing the jet for launch.

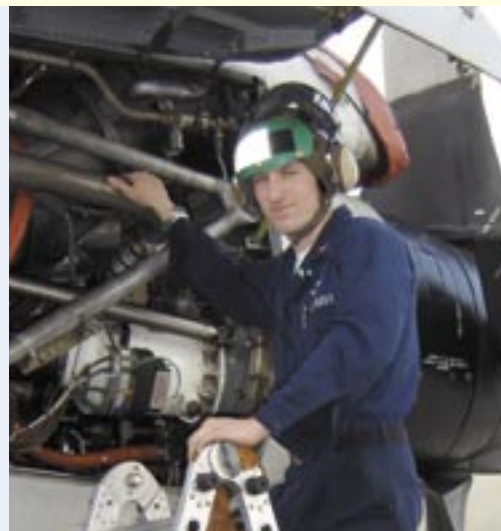
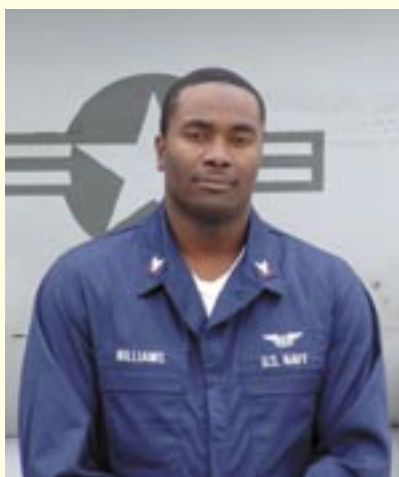
**AD2(AW) Daniel Masaveg
VQ-1**

On Dec. 28, 2004, while deployed to Kadena AB, Japan, AD2 Masaveg discovered a fuel leak coming from the bottom of the No.1 engine. He was doing a daily inspection on an EP-3E at the time.

AD2 Masaveg notified the W/C 110 supervisor and QA. After opening the engine's nacelle doors, "A" panels, and lower nacelle-access panels, he didn't see any obvious leaks. Further troubleshooting by AD2 Masaveg, the W/C 110 supervisor, and QA concluded a low power turn was required to locate the source of the fuel leak. During this turn, fuel was seen leaking from the fuel manifold directly on the labyrinth seal. The No. 1 engine was shut down, the hard line was retorqued, and a second turn was performed to check for leaks. If left uncorrected, this problem likely would have caused an engine fire.

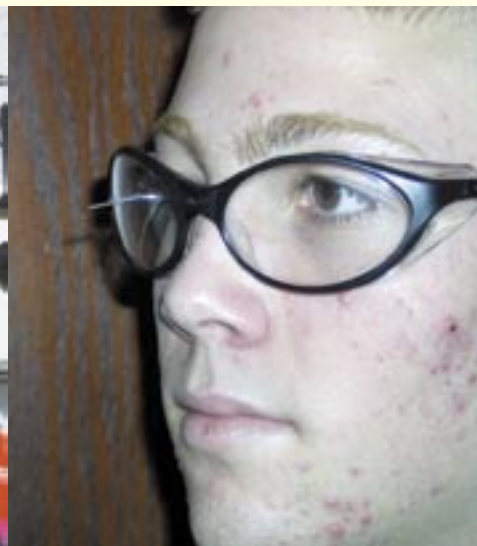
LCpl. Chandler Bunting
VMFA-533

LCpl. Chandler Bunting (MOS 6048 flight-equipment technician) was sewing intake covers for the squadron's FA-18D aircraft. This particular night, he was the sole member of the night crew for his shop and was doing the right thing by wearing the required PPE for this activity: safety goggles. While sewing an exhaust cover, the needle of the sewing machine broke in half and sent the needle flying—straight toward his right eyeball. The needle came off with such force that it embedded in his safety goggles and actually penetrated the lens by one millimeter. The needle was aligned with his eye and would have ended up in his eyeball had he not been wearing the safety goggles. By following established procedures and doing the right thing, LCpl. Bunting saved his eyesight and prevented a serious mishap. His professionalism and attention to safety allowed him to continue working that night and accomplish the mission...safely. Everyone has seen the posters of the needle in the eyeball; hopefully, just as many people will see this picture of the needle in the safety goggles.
